KIYOTA LAB.

Challenge of Geo-disaster Mitigation

Geo-disaster Mitigation Engineering

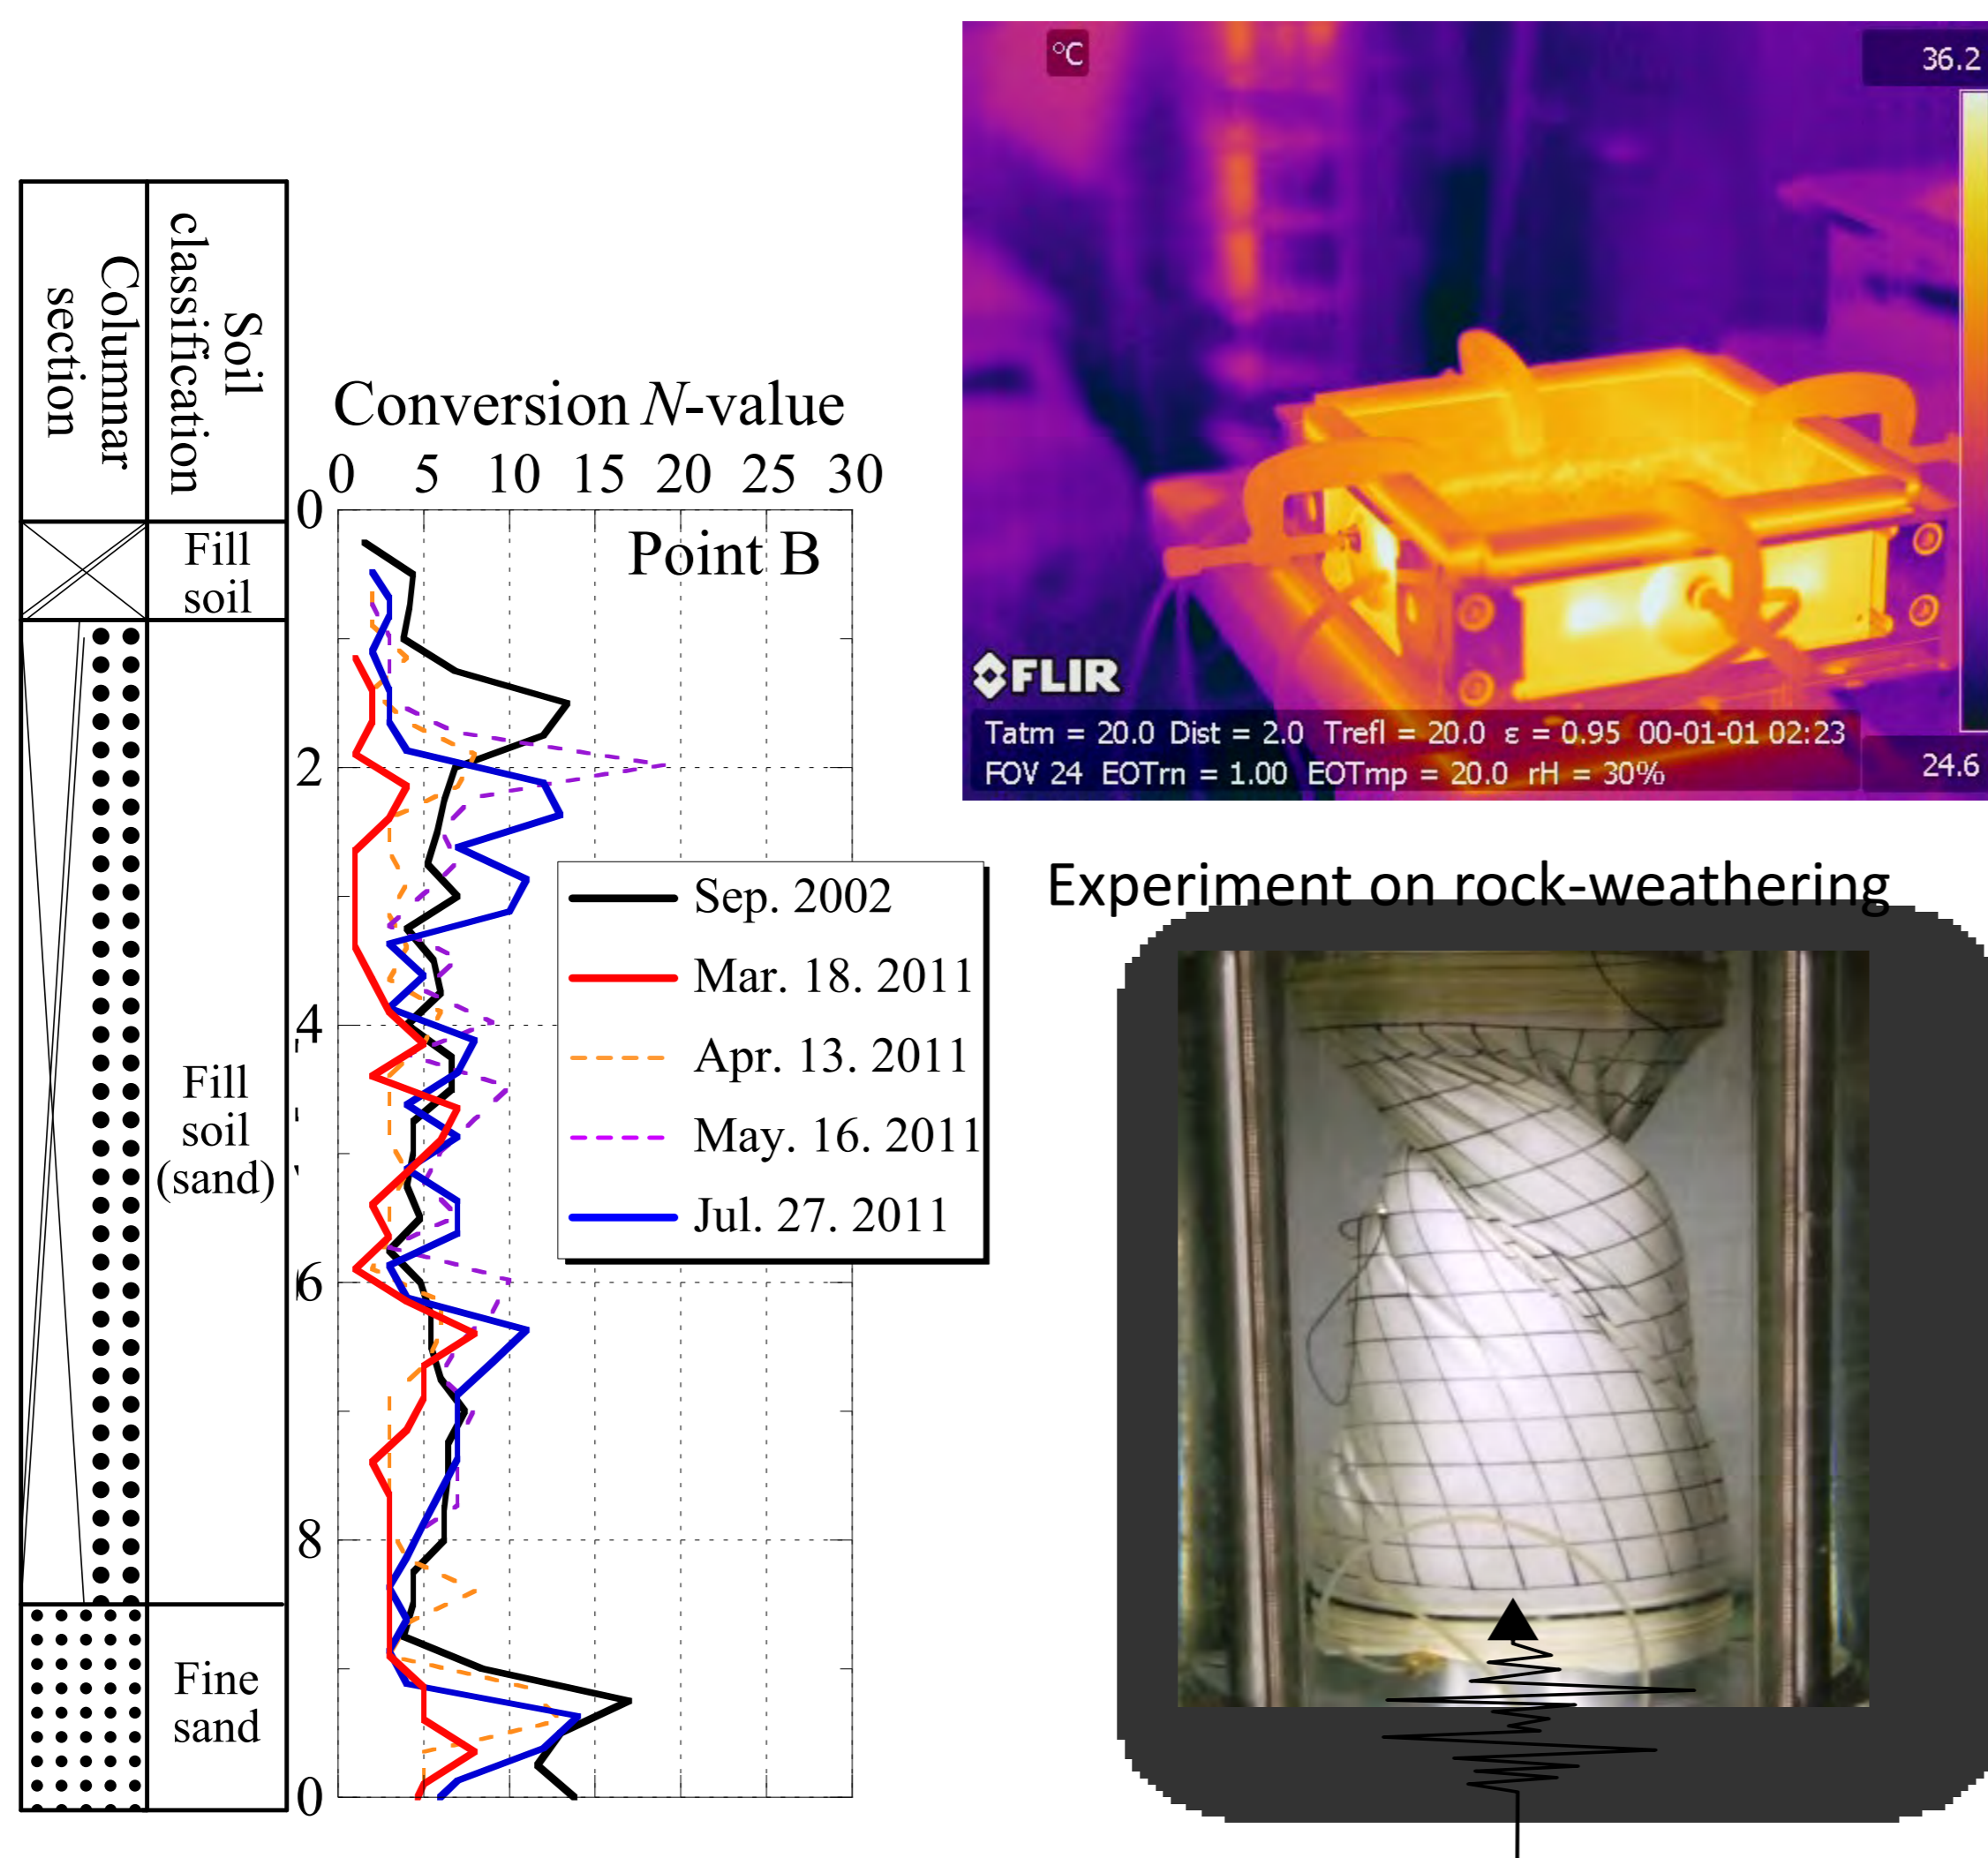
Newly-developed liquefaction hazard map for road network in Urayasu City

Field investigation and laboratory test on liquefaction problem

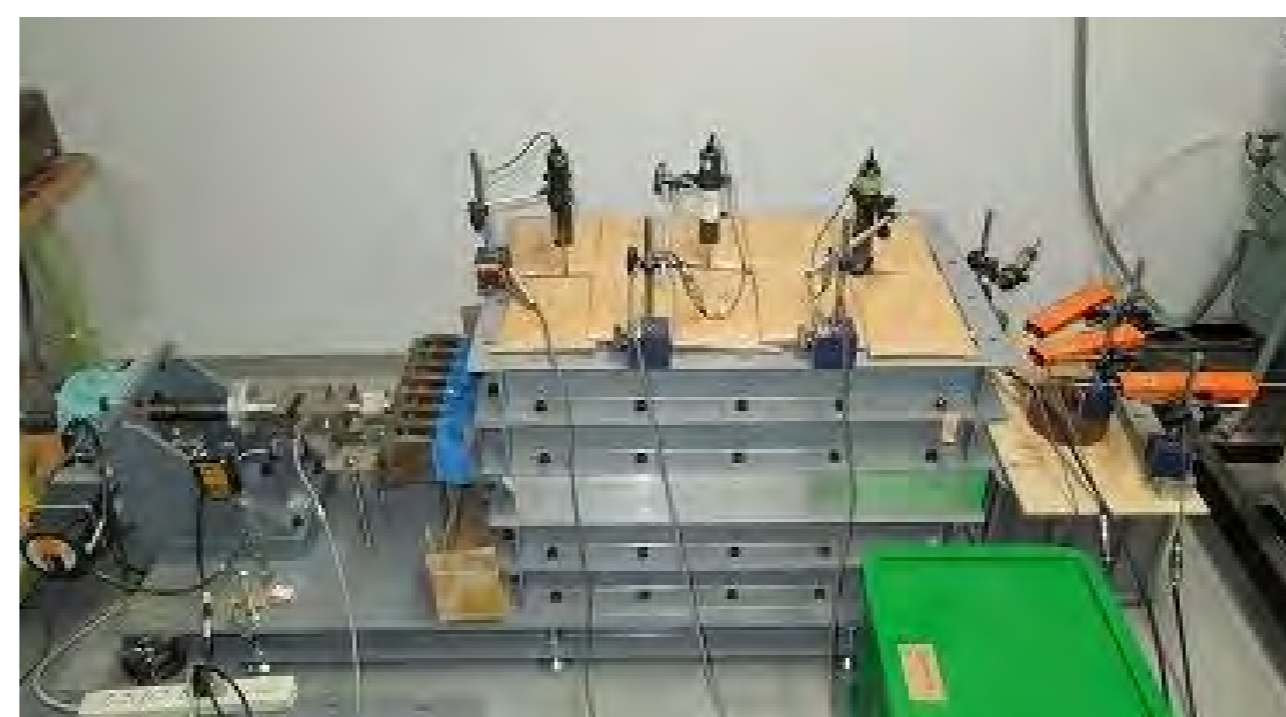
Pull-out test and shaking table model test on newly developed Geo-cell reinforced retaining wall
